STABILITY ANALYSES OF FOOTWALL SLOPES IN OPEN PIT MINING

LEANDRO R. ALEJANO

ABSTRACT: In this paper we analyse different failure mechanisms typically associated to footwall slopes, in order to evaluate its stability using the numeric code UDEC. These results will then be analysed and contrasted against the “Limit Equilibrium Method” (LEM) to determine the use of UDEC as a valid tool in footwall slope analysis. Two real cases, where the footwall slope failure took place through complex mechanisms, are finally analysed using UDEC.

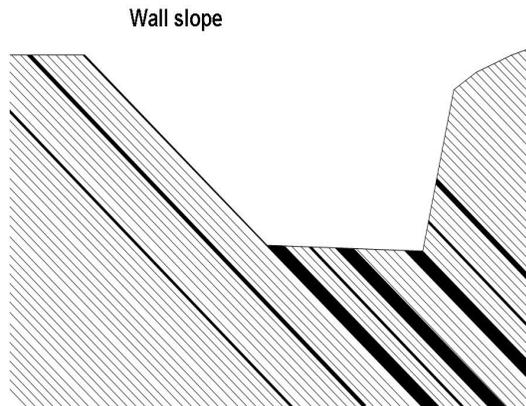
Figure 1. Typical footwall slope where the instabilities analyzed in this study may take place

In mineral deposits associated with sedimentary rock, the economic limit is commonly defined by the footwall of the deeper seam to be mined. Where open pit mines are developed in dipping strata, a high footwall slope may result, which is usually designed with an angle equal or less steep than that of the bedding planes to avoid planar failure (see Figure. 1).

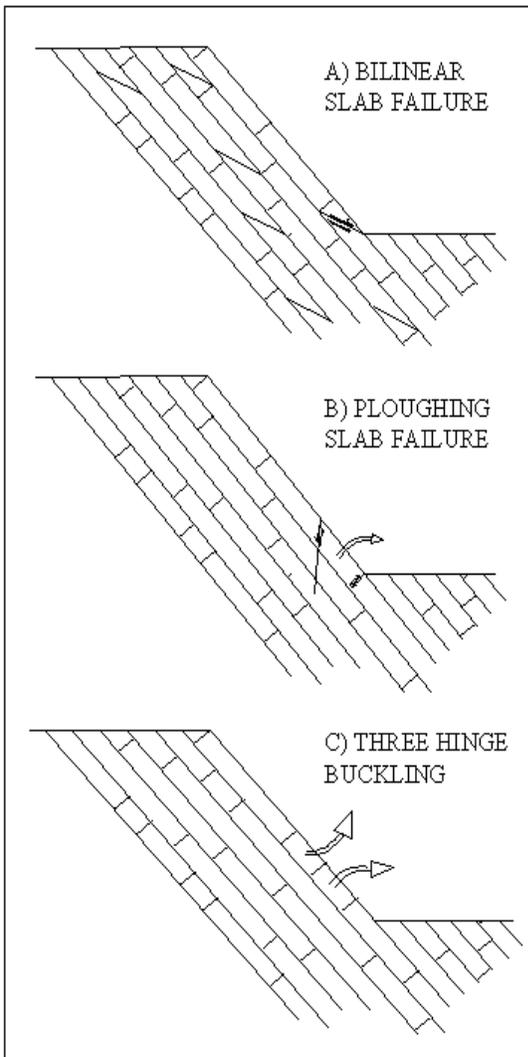
Figure 2. Totally discontinuity controlled failure mechanisms observed on footwall slopes, including A) Bilinear slab failure, B) Ploughing slab failure and C) Three hinge buckling

The most commonly encountered mechanisms, presented in Figure 2 include:

a) Bilinear slab failure, which involves sliding along a basal plane in combination with sliding along a secondary shallow dipping joint, which is undercut by the slope face (Fig. 2.A). In reference [2] this type of failure is reported in a mine.

b) Ploughing slab failure, which takes place when slab sliding along a primary discontinuity combines with sliding along a joint, which strikes sub-parallel to the slope face, causing the toe block to be lifted by sliding and eventually rotated out of the slope (Fig. 2.B). Although this mechanism is not very common Ramírez-Oyanguren [9] reported various cases, where this type of failure was observed.

c) Three hinge buckling, described by Cavers [10], is the third known mechanism of this type. It assumes the presence of at least three joints normal to bedding in the slope's lower part. Failure is initiated when enough water pressure exists in the basal plane to induce rotation or shearing along cross-joints causing the extrusion of blocks. (Fig. 2.C).

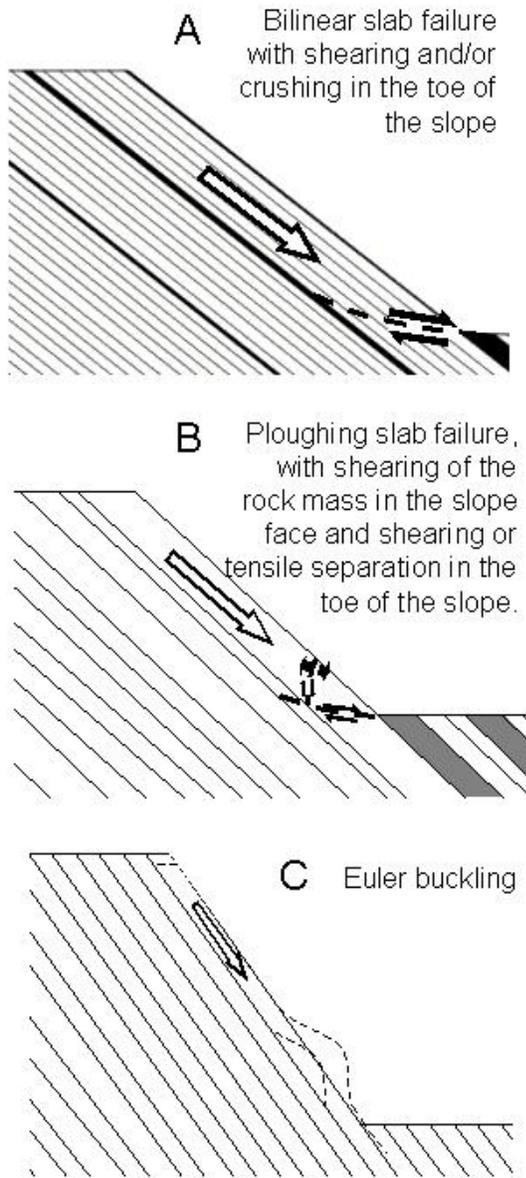
Figure 3. Partially discontinuity controlled failure mechanisms observed on footwall slopes, including A) Bilinear slab failure with shearing, B) Ploughing slab failure with shearing and tensile failure and C) Euler buckling

The three basic mechanisms of this type analogous to those fully controlled by discontinuities and presented in Figure 3 are:

a) Bilinear slab failure with shearing and/or crushing in the toe of the slope, similar to the one all along discontinuities, but with the failure of the rock mass penetrating through the slope toe. Recently Fisher [10] has studied in detail these mechanisms.

b) Ploughing slab failure, with shearing of the rock mass in the slope face and shearing or tensile separation in the toe of the slope.

c) Euler buckling of the first rock bed as presented by Cavers [11].

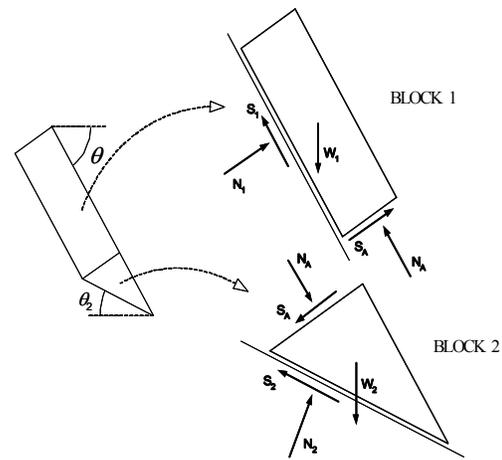
Figure 4. Bilinear slab failure analysis geometry

The stability analysis is done dividing the sliding elements into an active block (1) or slab and a passive block (2) in the toe (Figure 4). For the sake of simplicity, the calculations that follow assume null cohesion joints and no underground water.

First, the normal external force needed by the active block to be stable (N_A) is calculated, and then, this force is transferred to the resisting block to calculate the safety factor. The analysis needs an assumption concerning the state of the interface between the active and the resisting blocks. If we assume that this boundary is frictionless, it can be found that:

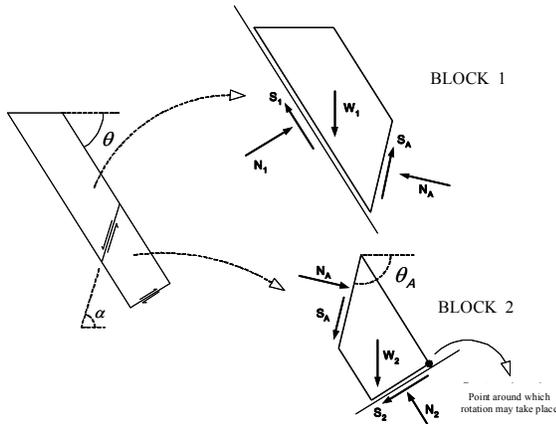
Figure 5. Ploughing slab failure analysis geometry

The method of analysis is similar to the bilinear slab failure (see Figure 5). But in this case two further topics should be considered in greater detail.

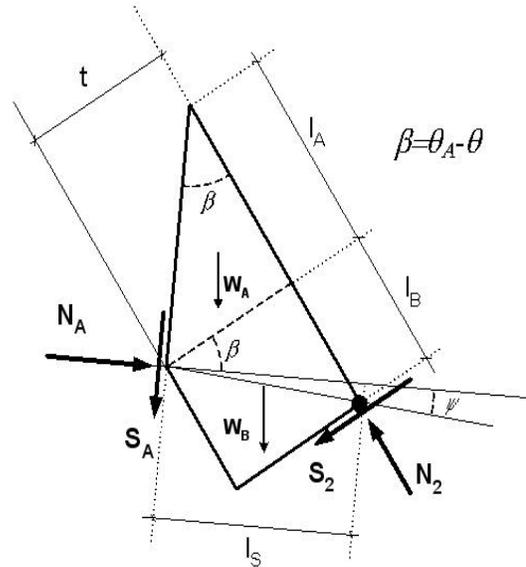
Figure 6. Detail of block 2 for the toppling analysis

For the limit equilibrium of the toppling case, some geometric values are needed, which are defined in Figure 6. Finally, the FoS for the toppling mode is:

The analysis studies a 25 m slope, dipping 50° ($\theta=50^\circ$), formed by 1.5 m strata ($t=1.5$ m), and with a joint striking parallel to the slope in its toe and dipping towards the slope with $\theta_A=95^\circ$, according to Figure 5. There is also a joint normal to bedding passing through the slope toe. For bedding planes $\phi_1=30^\circ$ and for the rest of the joints $\phi_A=\phi_2=20^\circ$. The distance so called I_B in Figure 6 is $I_B=2.293$ m.

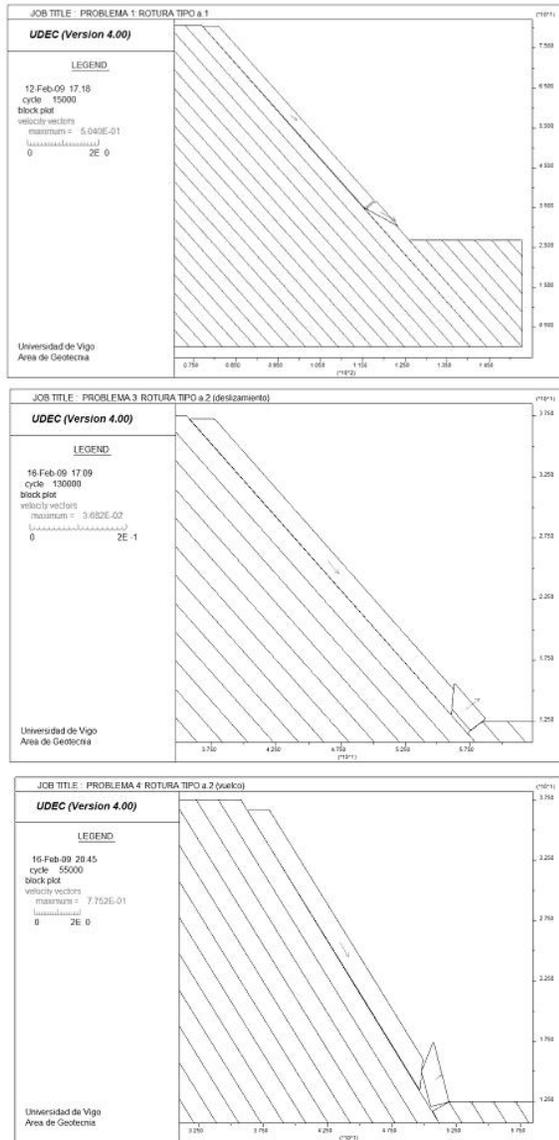
Figure 7. UDEC response of examples 1 to 3, where the different mechanisms can be observed

The results are shown in Table 1. In this case LEM and UDEC-SRRT compare well, for they both indicate toppling failure, and the FoS values are similar in both cases. Figure 7 shows the UDEC mechanisms of examples 1 to 3.

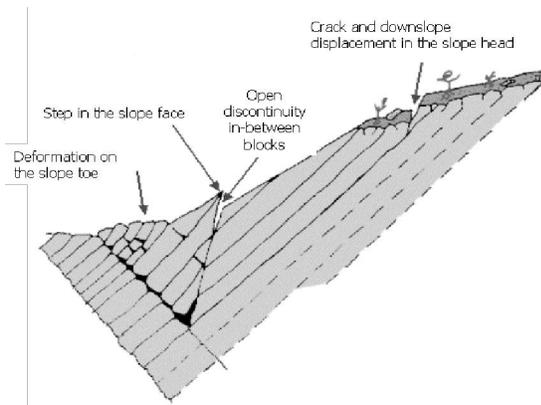
Figure 8. Geometry and identified features of a wall slope failure in road according to [12]

We study the instability of slope occurred during the excavation of a highway in northern Spain. This case was presented in detail by some authors [12]. The geometric description of the slope is shown in Figure 8.

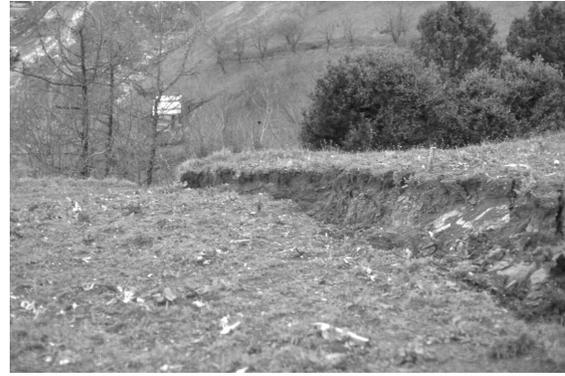
Figure 9. Picture of the tension crack in the upper part of the slope

The instability was finally caused by the water pressure after a very rainy period. A detail of the upper part of the slope is illustrated in Figure 9.

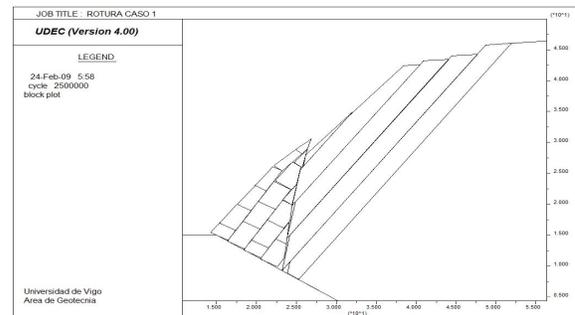
Figure 10. UDEC mechanism of the failure of a wall slope failure as developed by the authors

The UDEC analysis determined that the dry slope was stable, whereas the inclusion of water induced the instability. The failure mechanisms as derived from our UDEC approach is illustrated in Figure 10.

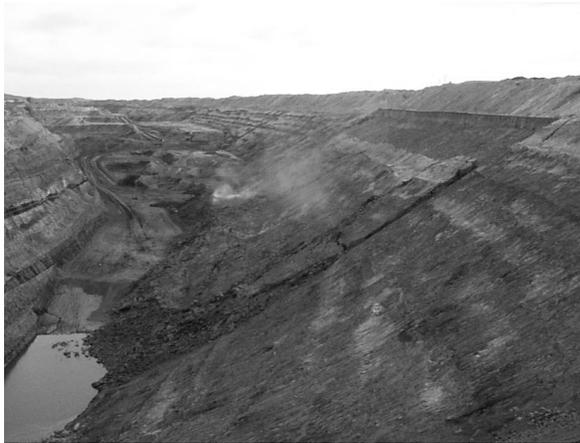
Figure 11. Picture of the footwall slope failure in Leigh Creek mine

The LEM analyses determined that the slope was a stable one. Nevertheless, when the slope attained a depth of 100 meters as shown in Figure 11 the slope failed. Ten very weak 1 m thick strata slid through a very weak bedding plane located 10 m below the slope face.

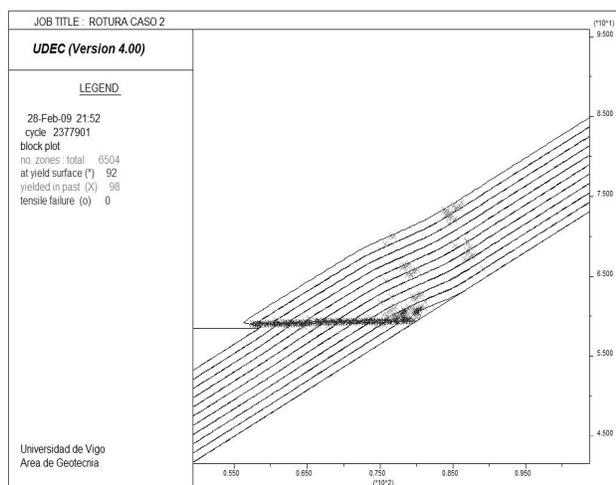
Figure 12. Detail of the UDEC model showing the shearing of the rock in the base of the slope failure in Leigh Creek mine. Remark that shearing of the rock mass is required for toe breakout

The UDEC model is able to determine the instability of this slope only partially controlled by discontinuities. The failure mechanism is shown in Figure 12, where it is observed how the toe breakout needs shearing of the rock mass. This topic of the analysis of biplanar dip slope
